If alarm code E90 is displayed on the control panel, it means no water is flowing through the system. Check and make sure of the following:

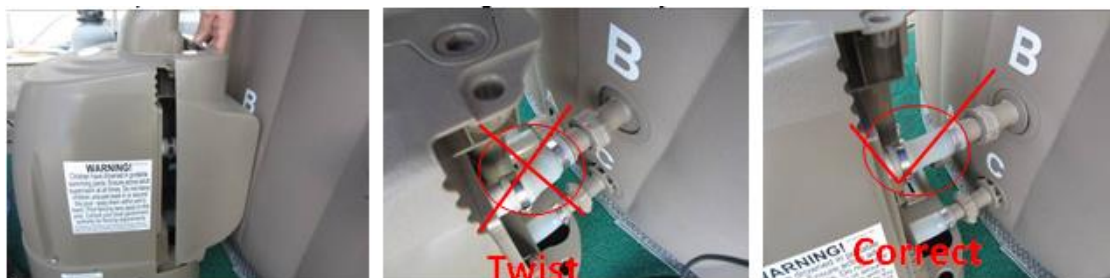
If there is no water flowing after removing the filter cartridge assembly: Check and ensure the in/outlet connections between the spa tub and the spa control unit are not blocked, twisted or leaking.

If E90 still shown, there might be something wrong with control base unit. Please contact your nearest consumer service center for replacement.
